Arizona Public Media New Facility

The Paul and Alice Baker Center for Public Media

Construction Project Update – May 2024

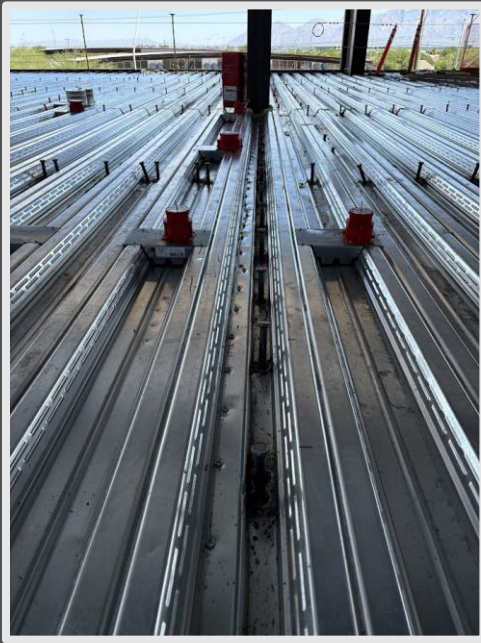
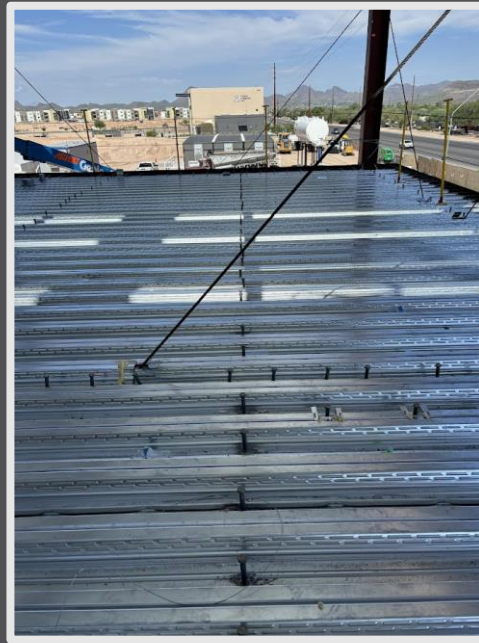
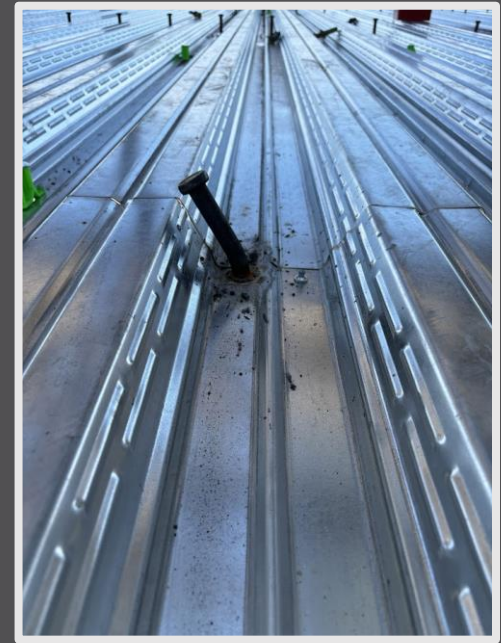
QUALITY MOMENT

On each of the metal decks there are shear studs, also called nelson studs, that are welded to the beams through the deck and are later encapsulated in the concrete to help all the parts of the system work together to support the loads of the building. As these studs are installed on beam lines, they are in straight lines, but you'll see in the images above that some of these studs aren't straight anymore. This is because the test to ensure that they are properly attached is to bend one of every 30-40 studs. If the stud bends, it is appropriately attached. If it breaks off, it was not attached well enough and must be redone.

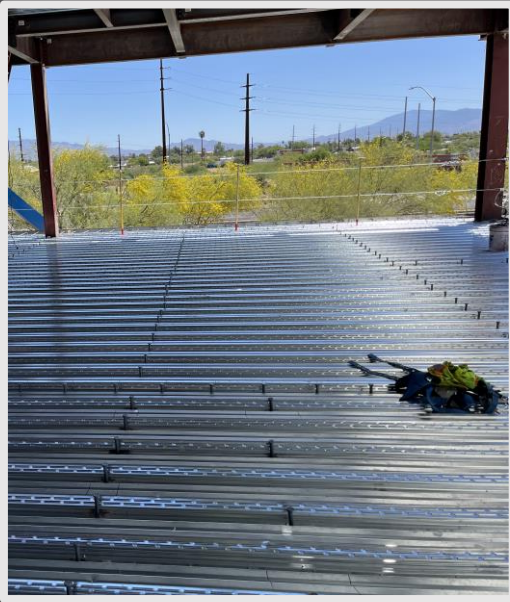
Deck at turn over

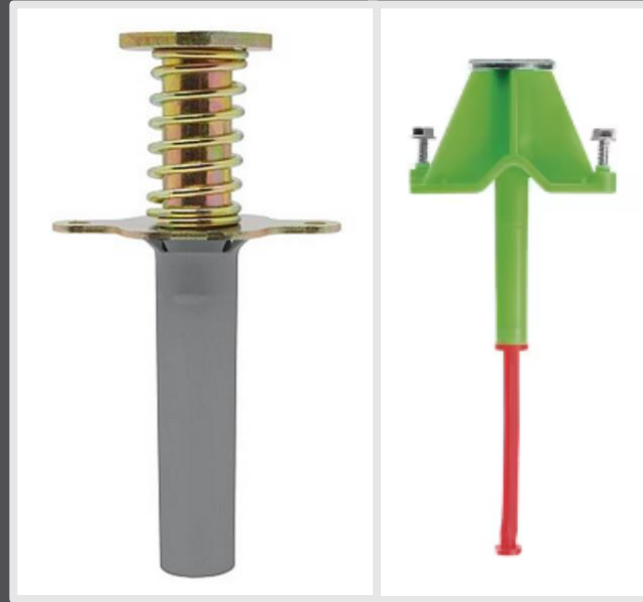
Bangers being used on the project

This month the first section of decking (level 2 east side) was completed and turned over from the steel contractor to the MEP trades to begin laying out their bangers. Bangers are supports that are installed in the metal deck before concrete is placed to support the overhead utilities for the floor below. You install these by “banging” a hole in the deck with a spear-like tool, inserting the banger, and screwing it into place so that it doesn’t move during the concrete placement. This system is more efficient for installing overhead supports rather than drilling and post installing anchors after the concrete slab on metal deck has been placed.

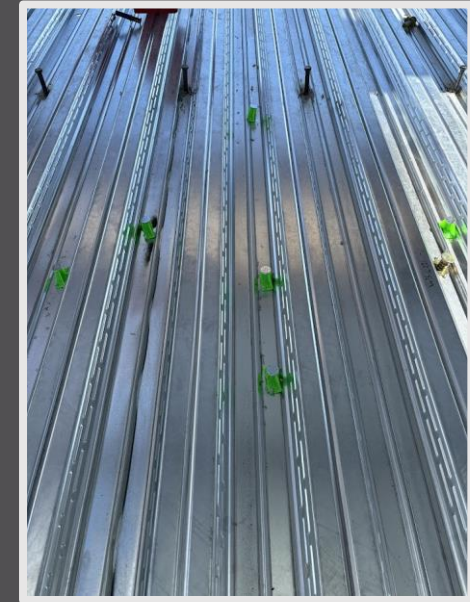
Bangers installed in the deck

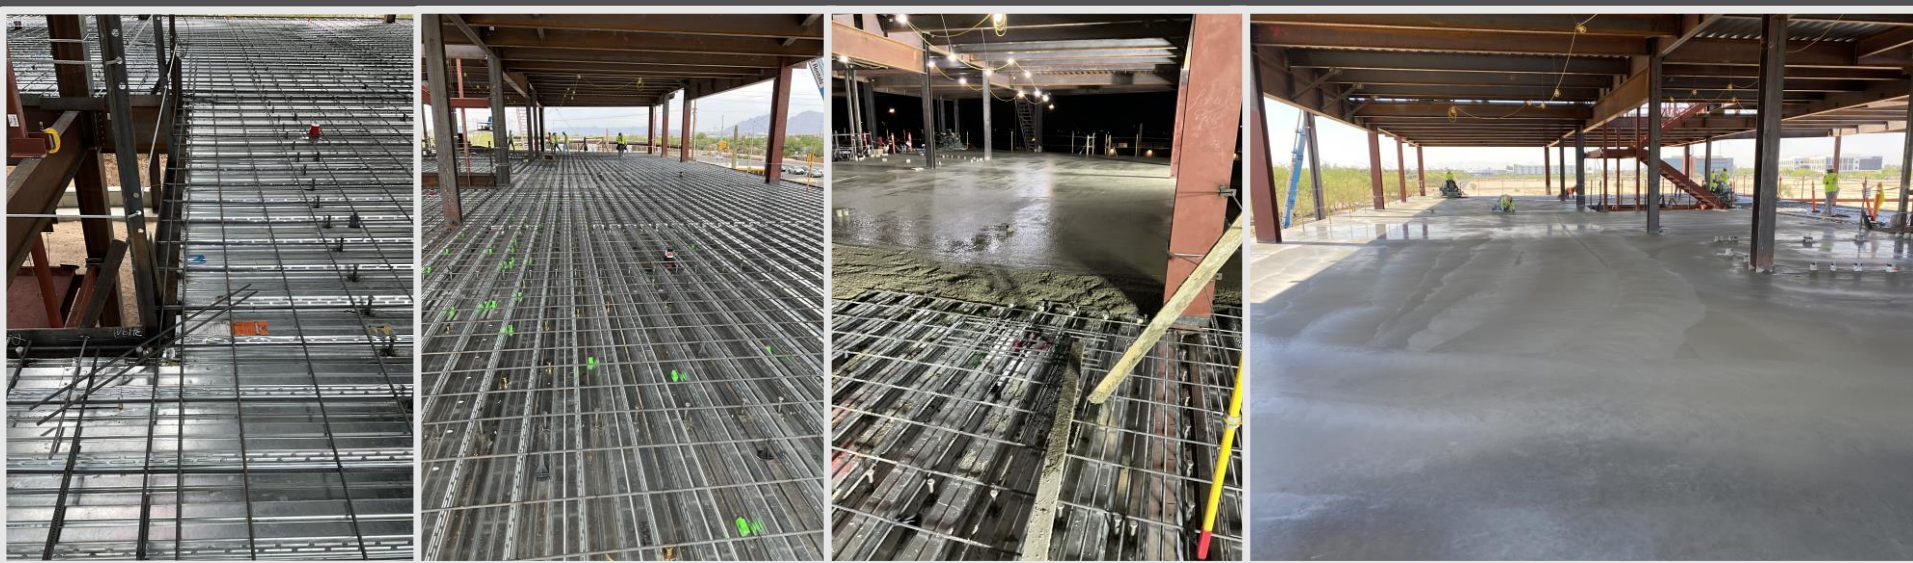
Rebar in place, deck ready for concrete

Halfway through the placement

Finishing the slab

After the MEP trades finished with their layout, the concrete crew placed the rebar and the first slab on metal deck on 6/14 beginning at 1:30am. There are many reasons that slab placements are done in the middle of the night including; the heat in the middle of the day would cause the water to evaporate from the mix too quickly causing larger cracks, the traffic in the middle of the night is much better for moving a lot of concrete trucks in and out, a few hours after the concrete is placed a finishing crew comes through and smooths the surface of the concrete and this process can take hours, the concrete trucks and pumps take up a lot of space on site placing early morning or over night clears the equipment off the site by the time the rest of the crews show up to work.

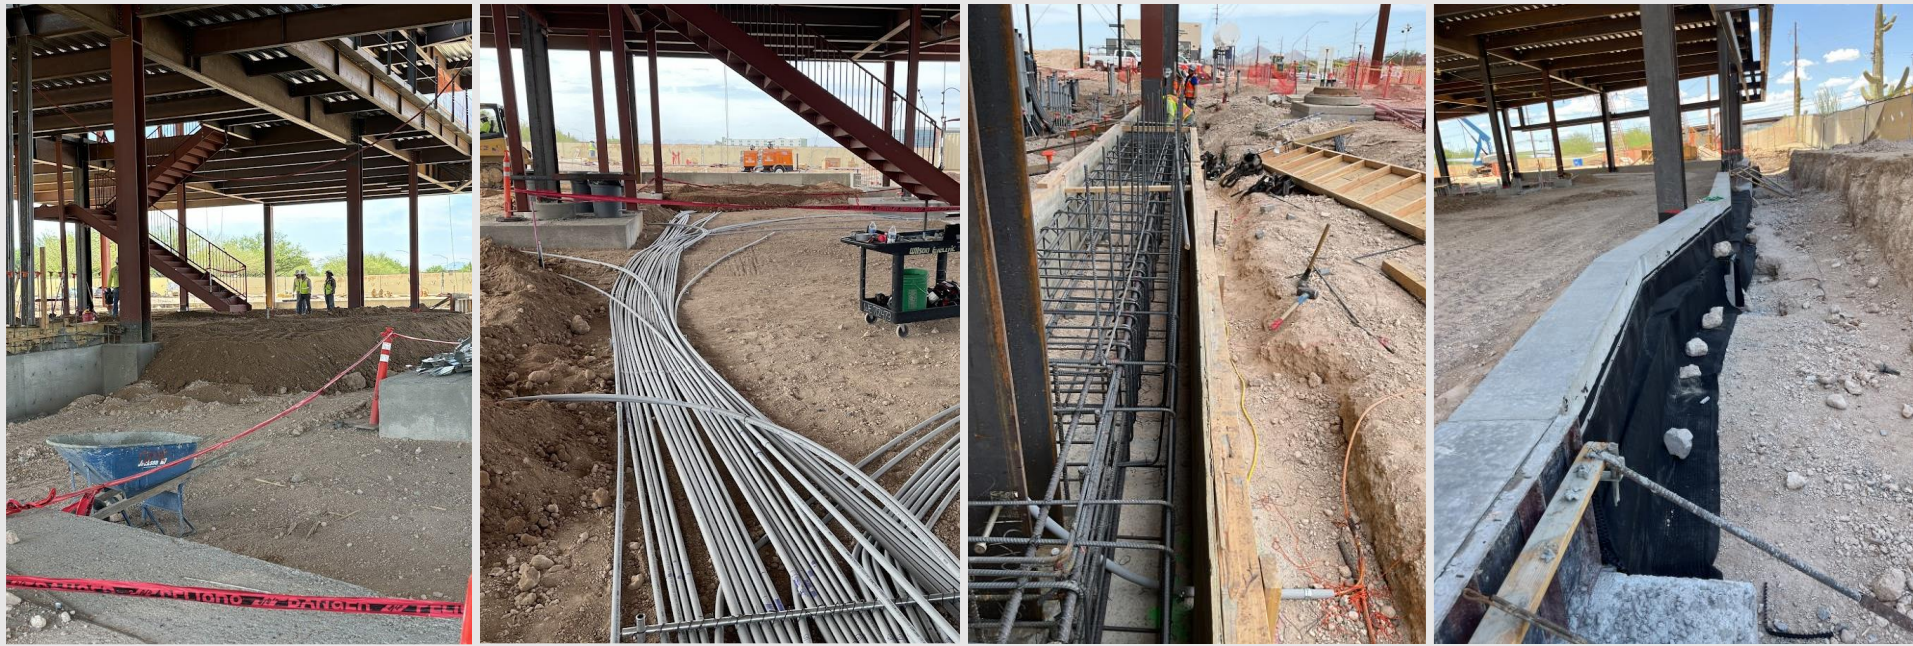
Other activities in June included back filling some of the “bathtub” on the East side; installing the small distribution conduits; placing concrete grade beams; and starting the waterproofing on the exterior of the building.
